October 22, 2015

The purpose of this letter is, first to state that I inspected a residential property located at 125 Sunny Acres Road, Jonesborough, TN 37659 on October 16, 2015 and second to describe in detail the findings of my inspection and my recommendation to cure.

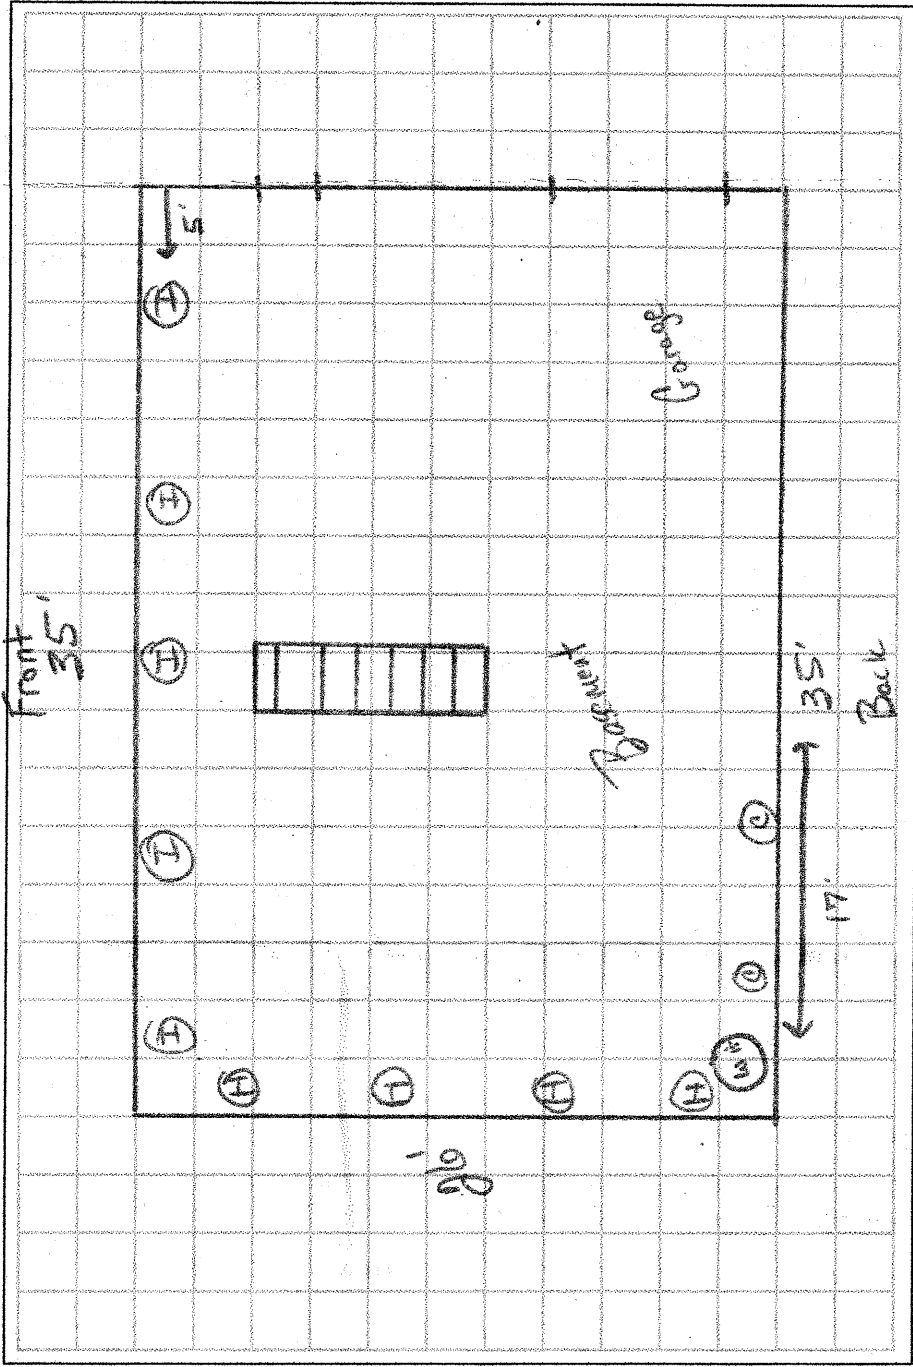
Blue Canyon Solution Design Form

Description of the residence; is a three bedroom house with living room, kitchen, one full size bath and a full size basement consisting of 910 square feet of living space and same for basement. Foundation problems exist on three of the four basement walls. The only wall not affected is the drive under garage entrance wall which is full exposed (no backfill). The other three walls, I will describe as (1) The Front Wall, (2) The Back Wall and (3) The End Wall, see "Solution Design Form" attached hereto.

The front wall has two stair-step cracks, one on each end and a parallel crack 26 feet 9 inches long running from one stair-step crack to the other end and is one block from the top and ten blocks from the floor up. See attached photos.

The back wall has three stair-stepping cracks, one on each end of the wall and one about 3/4's of the way in and a parallel crack 18 feet 8 inches long 3 blocks down from the top and 4 blocks up from the floor. See attached photos.

The end wall has two major stair-step cracks and one parallel crack 22 feet 8 inches long running from one stair-step crack to the other, one block down from the top and 2 blocks up from the floor. See attached photos.

Install nine (9) four inch I-beams flush to the walls and three feet into the basement floor with one yard of concrete poured into the basement floor hole where the I-beam will be installed running from below the basement floor to the top of the floor joist as indicated on the "Solution Design Form". And three carbon fiber strips 10 inches wide and 8 feet long on the back wall. These carbon fiber strips have been proven to withstand 80,000 lbs. of pressure.

Special Instructions: 900 - I-Beams
Geo-Carbon Fiber Strip
